PERFORMANCE TEST REPORT

Report No.: B7179.01-122-42
Test Dates: 04/17/12
Through: 04/18/12
Report Date: 06/13/12
Revision 1: 04/20/15

Series/Model: Truline 800 and 1200 Series

Product Type: PVC Seawall

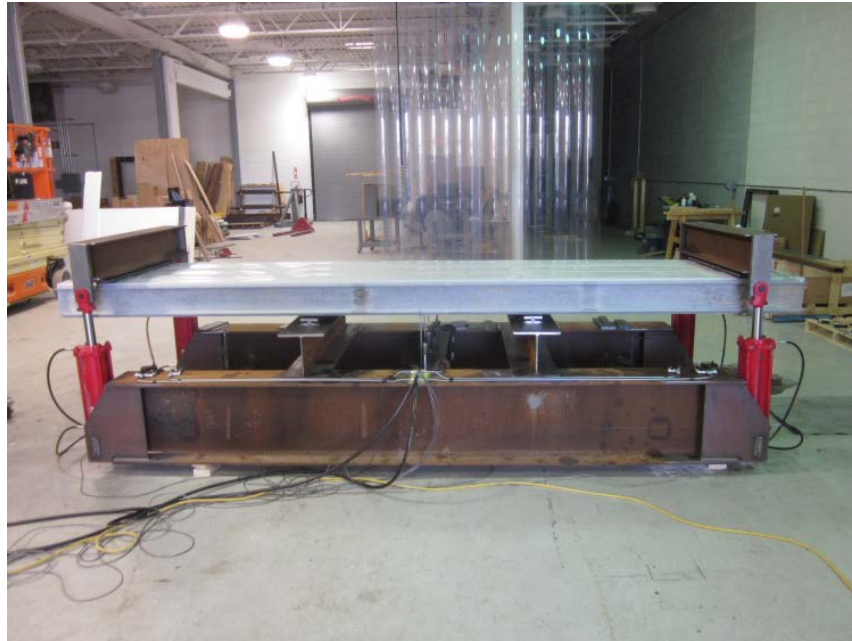
**Photo No. 1
Typical Test Setup**

Test Setup: Each seawall specimen was placed horizontally on a steel test fixture and supported on 50" centers. Each support location contained a 1" diameter by 36" long lubricated steel bar sandwiched by two 1/2" thick by 4" wide steel support plate. Each of the support plates was machine with a 1/2" radius to capture the steel rod and allow up to 9 degrees of rotation.

The seawall was loaded using two steel load beams on 144" centers. The load beams also contained the 1" diameter lubricated steel rod and 4" wide support plates. Each load beam (including the pivot plates and pivot bar) weighed 283 lbs. The ends of each of the load beams were connected via steel pins to the rod end of a 5" bore hydraulic cylinder (2" diameter rod). The cap end of the hydraulic cylinder was mounted via steel pins to the steel text fixture (see Photo #1 in Appendix A).

The four hydraulic cylinders (one at each corner) were connected to a 1250 psi hydraulic system to provide up to 41000 lbs of load at each end of the seawall. To determine load, a pressure transducer was connected to a manifold where all of the hydraulic lines terminate. All hoses and supply tubing was matched to length.

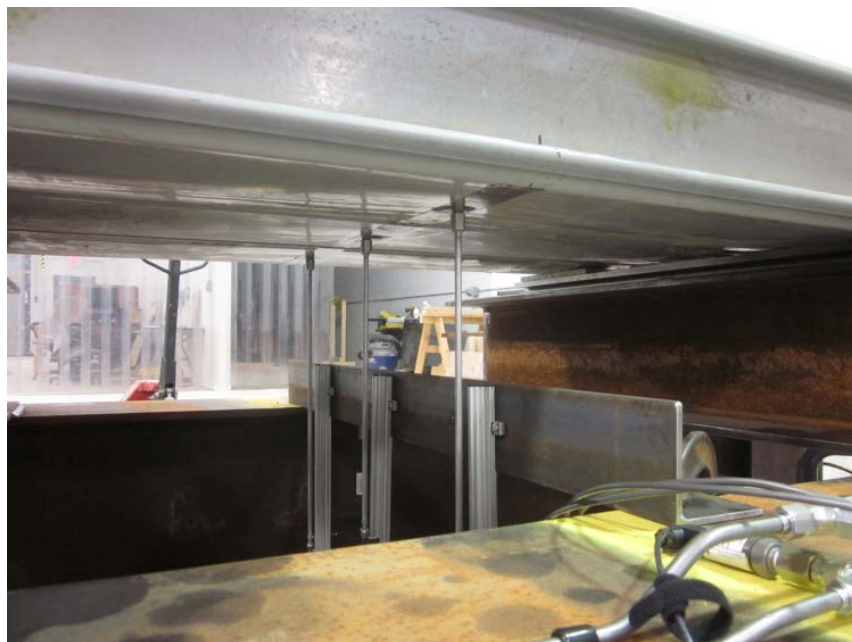
**Photo No. 2
Bottom Center of Test Specimen showing LVDT locations**

Three linear variable differential transformers (LVDT) mounted to the center of the test fixture recorded deflection of the seawall system. The LVDTs were located at the center of each extrusion for the 8" thick specimens (12" centers) and at the center of each extrusion and center of the wall (seam) of the 12" specimen (9" centers). The transducers have an accuracy of ± 0.001 inches.

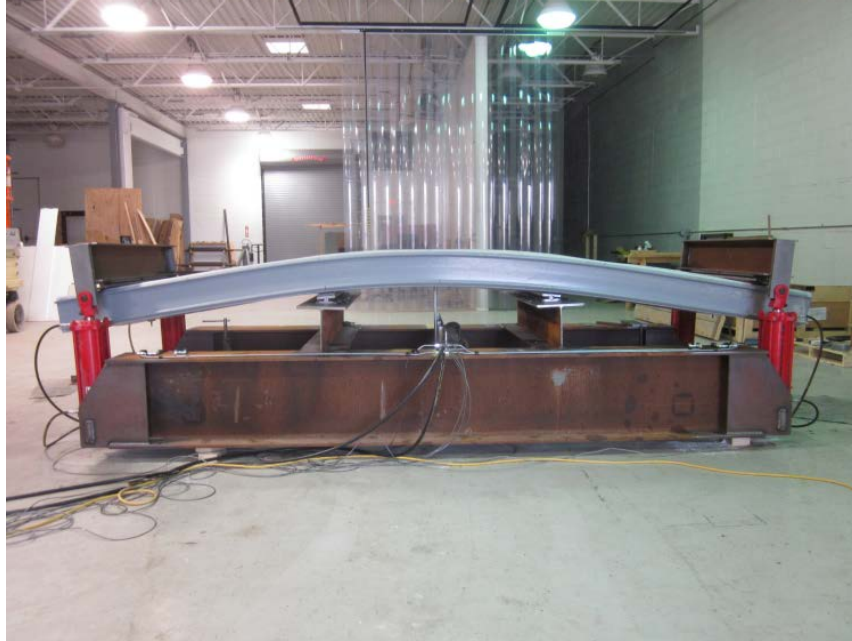
Photo No. 3
Typical 8" Thick Specimen at Full Cylinder Travel

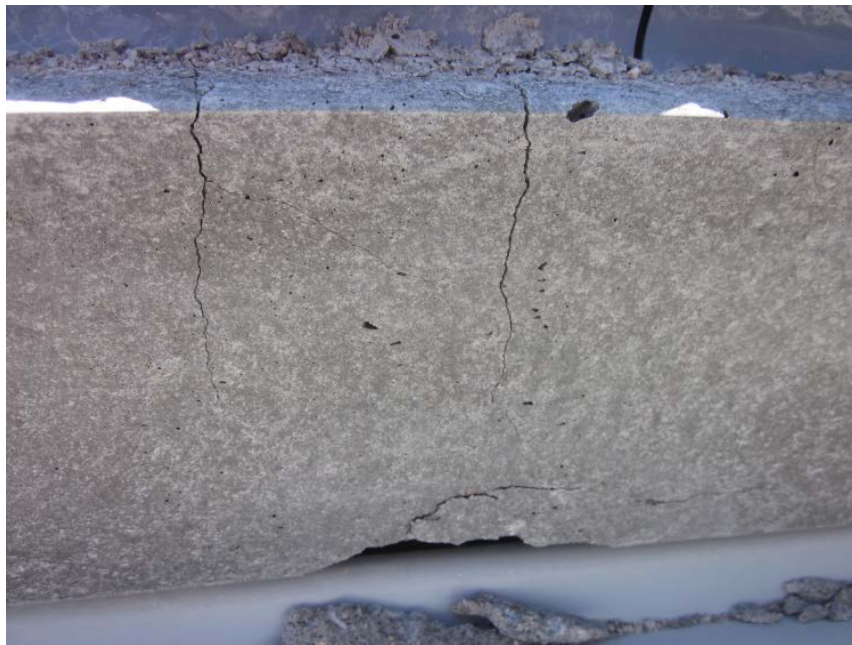
Photo No. 4
Typical Cracks in 8" Thick Specimen after Testing (End Cover Removed)

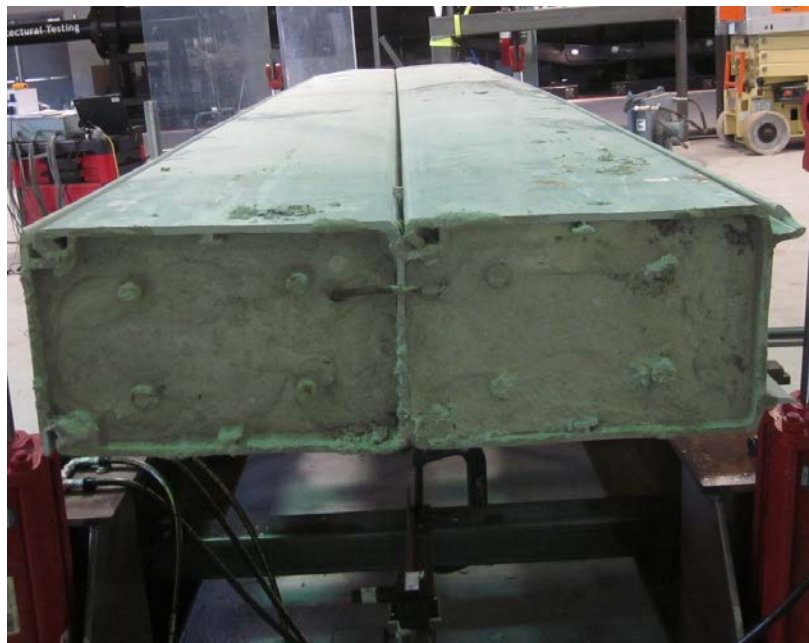
Photo No. 5
End View of 12" Thick Specimen (Series 1200)

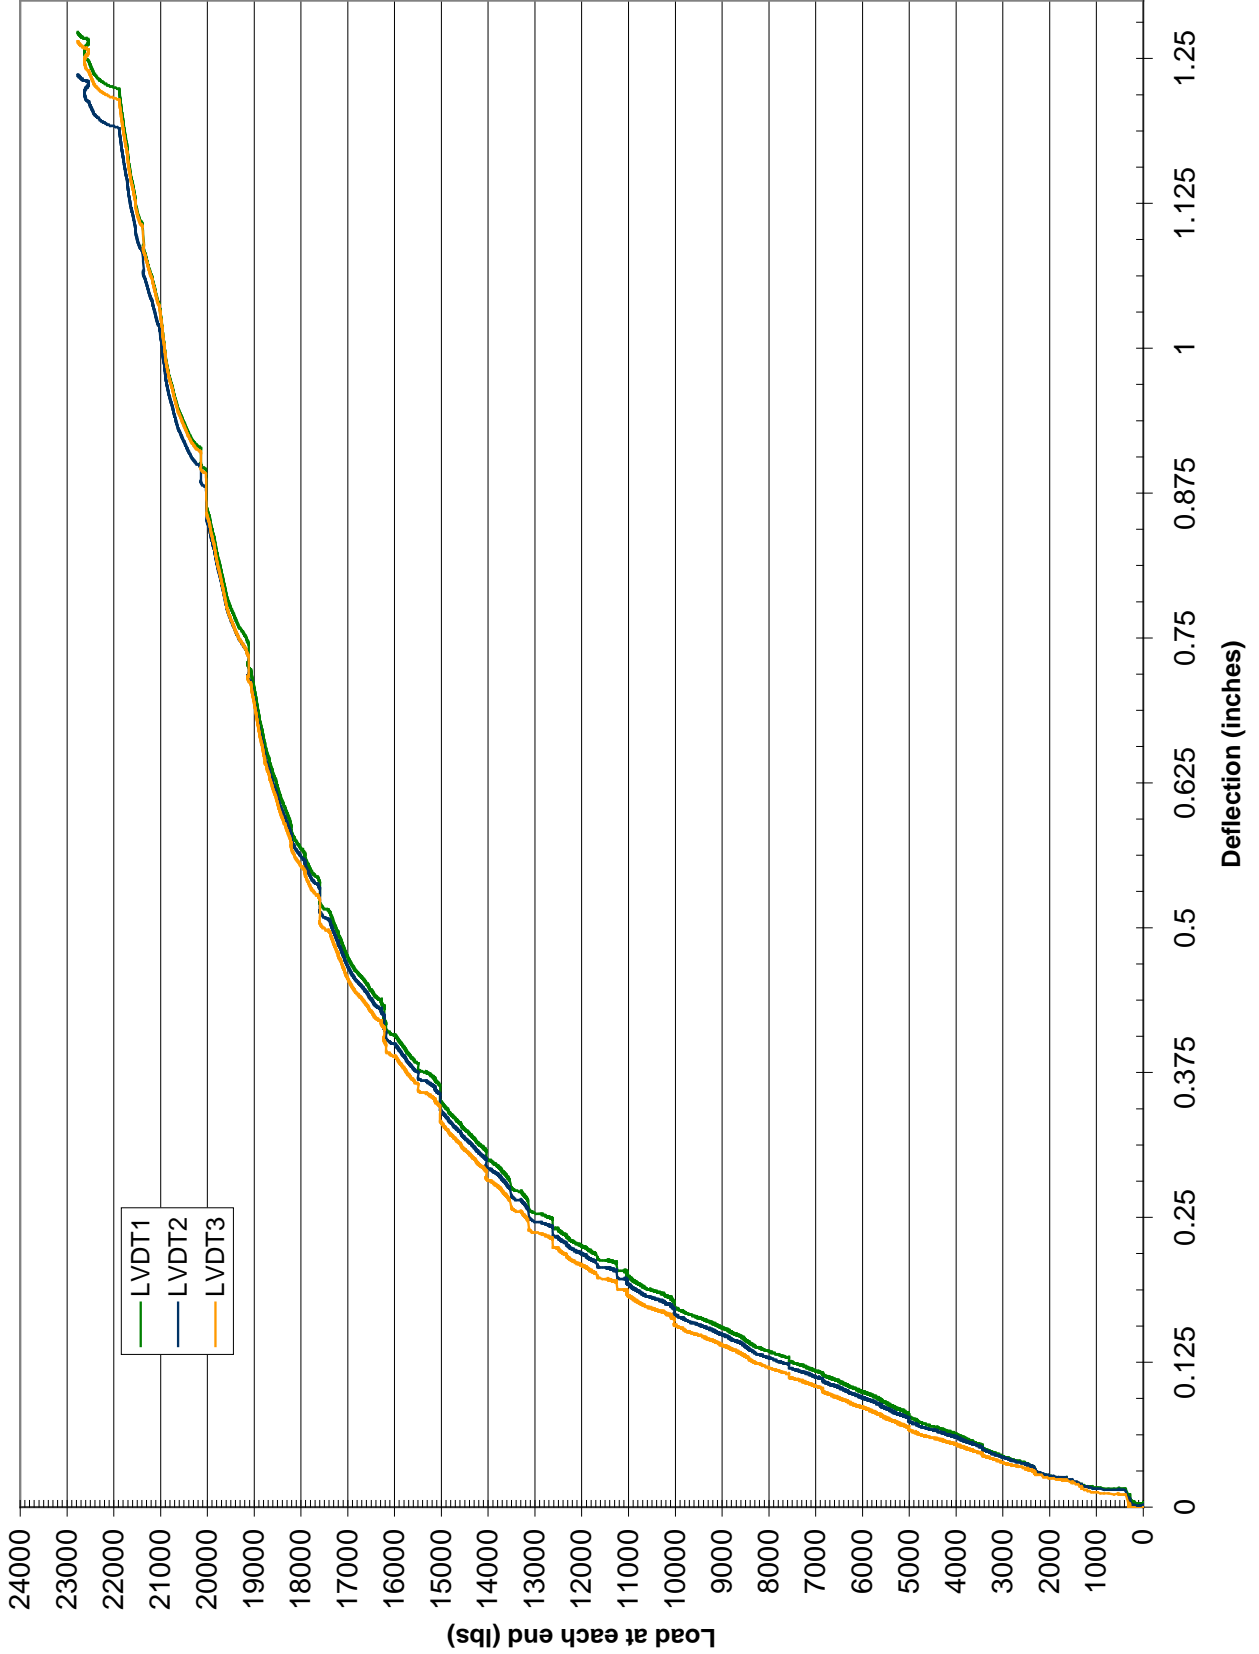
PVC Seawall Flexural Test (Specimen #2- 800 Series)

Specimen #2 (800 Series) - 04/12/12 - 62°F			
Applied Load (lbs)	Displacement (LVDT)		
	1	2	3
1000	0.023"	0.024"	0.022"
2500	0.038"	0.038"	0.034"
5000	0.078"	0.075"	0.067"
7500	0.126"	0.121"	0.113"
10000	0.173"	0.167"	0.158"
15000	0.352"	0.345"	0.335"
20000	0.866"	0.854"	0.862"
22773*	1.277"	1.239"	1.271"
0 (1 min. recovery)	0.477"	0.449"	0.455"

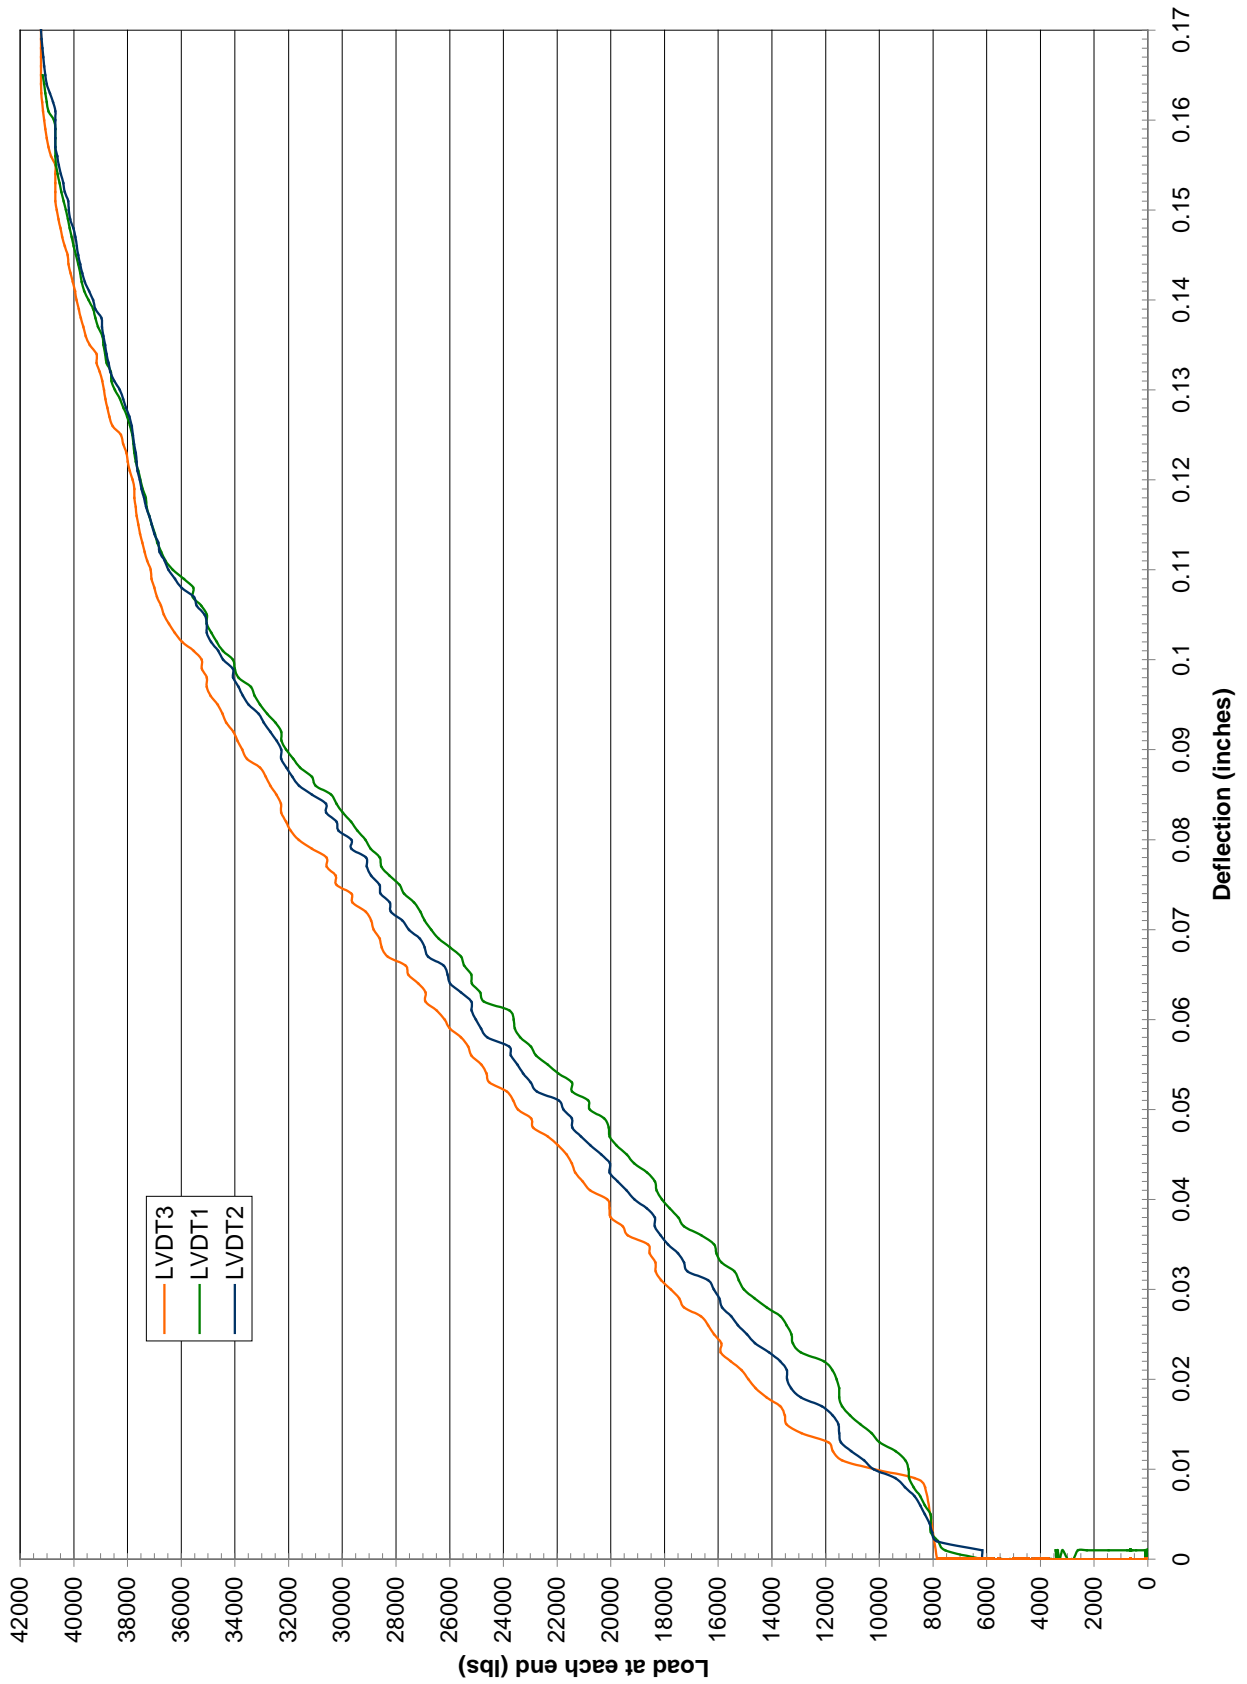
PVC Seawall Flexural Test (Specimen #1, 1200 Series)

Specimen #1 (1200 Series) - 04/13/12 - 60°F			
Applied Load (lbs)	Displacement (LVDT)		
	1	2	3
1000	0.000"	0.000"	0.000"
2500	0.001"	0.000"	0.000"
5000	0.001"	0.000"	0.000"
7500	0.002"	0.000"	0.000"
10000	0.014"	0.004"	0.000"
15000	0.031"	0.020"	0.001"
20000	0.048"	0.038"	0.019"
25000	0.065"	0.056"	0.037"
30000	0.084"	0.076"	0.056"
35000	0.105"	0.098"	0.078"
40000*	0.156"	0.152"	0.132"
0 (1 min. recovery)	0.046"	0.040"	0.030"

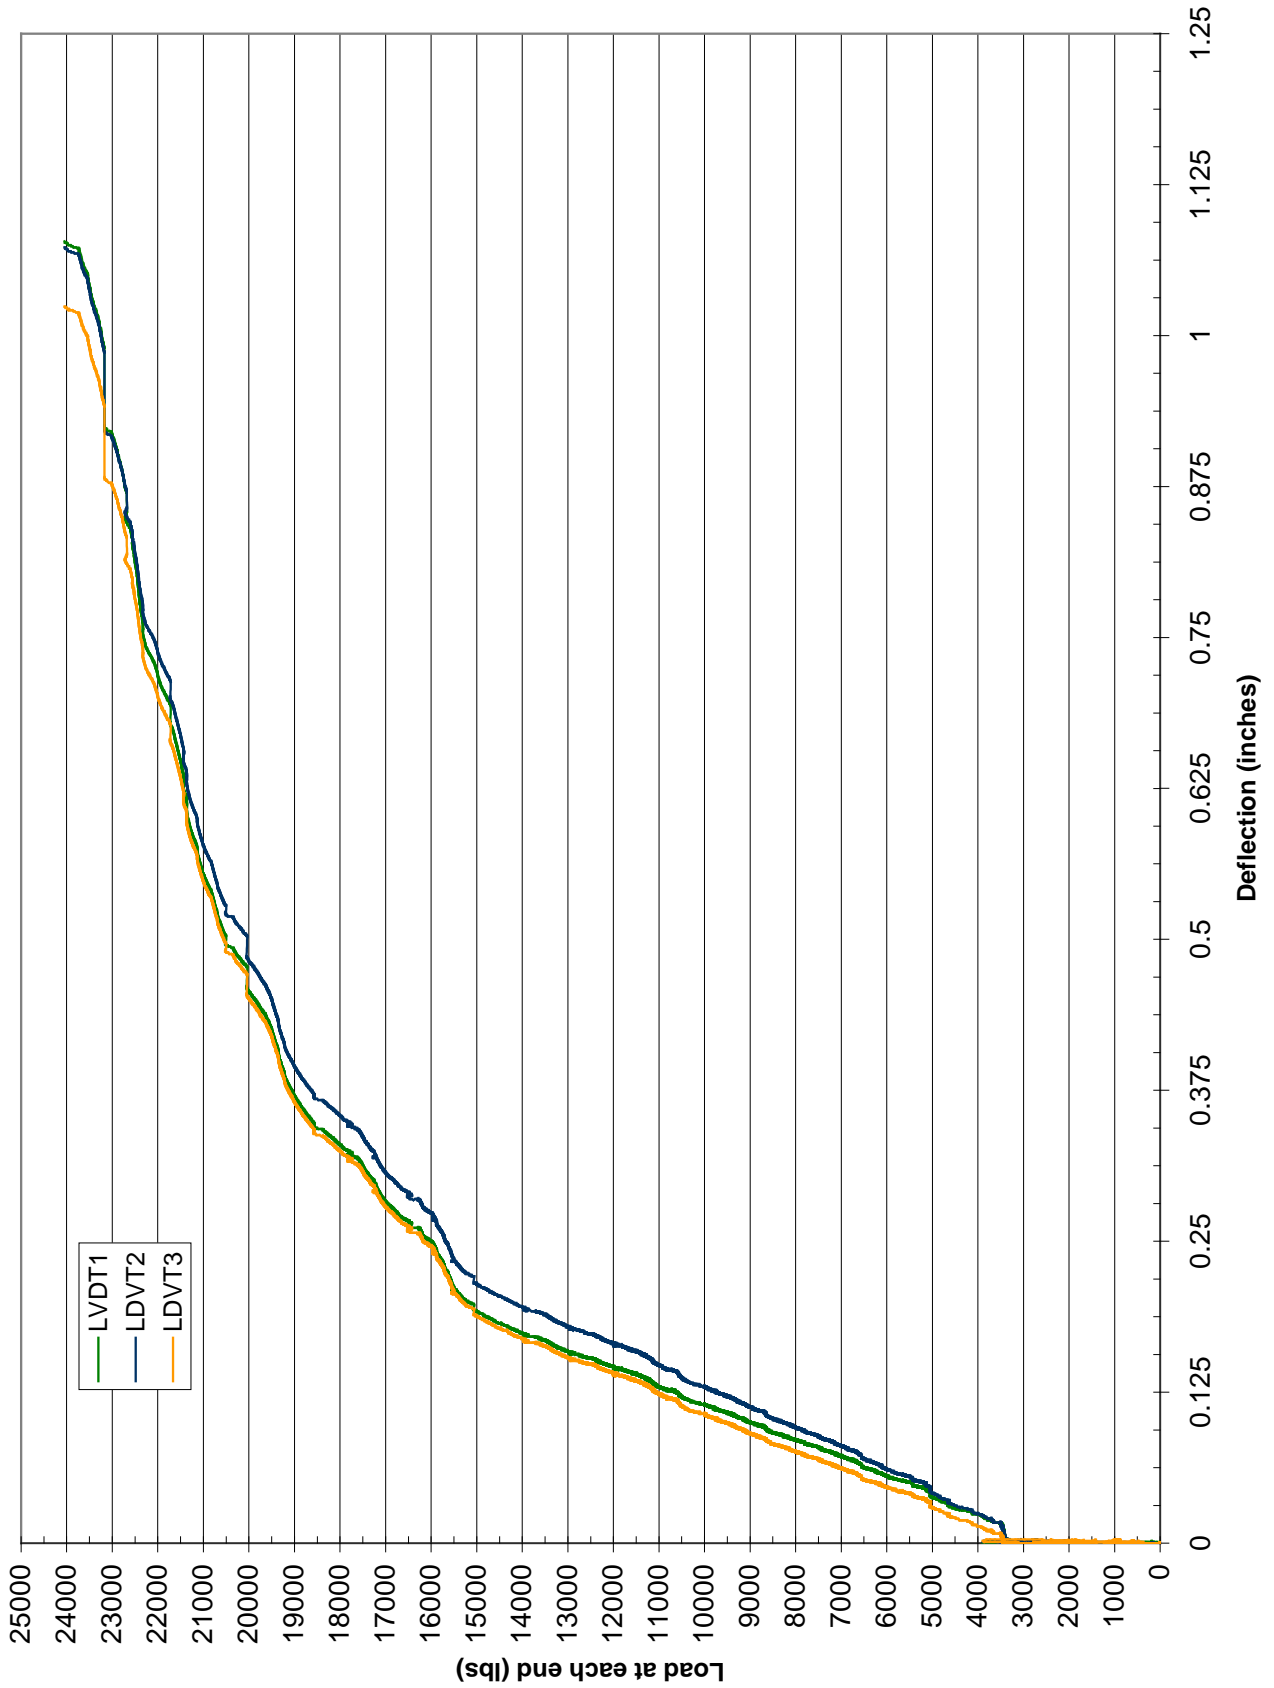
PVC Seawall Flexural Test (Specimen #4 - 800 Series)

Specimen #4 (800 Series) - 04/13/12 - 63°F			
Applied Load (lbs)	Displacement (LVDT)		
	1	2	3
1000	0.001"	0.000"	0.001"
2500	0.000"	0.001"	0.001"
5000	0.041"	0.045"	0.032"
7500	0.079"	0.089"	0.070"
10000	0.115"	0.130"	0.107"
15000	0.194"	0.217"	0.190"
20000	0.463"	0.488"	0.457"
24053*	1.080"	1.076"	1.027"
0 (1 min. recovery)	0.362"	0.350"	0.328"

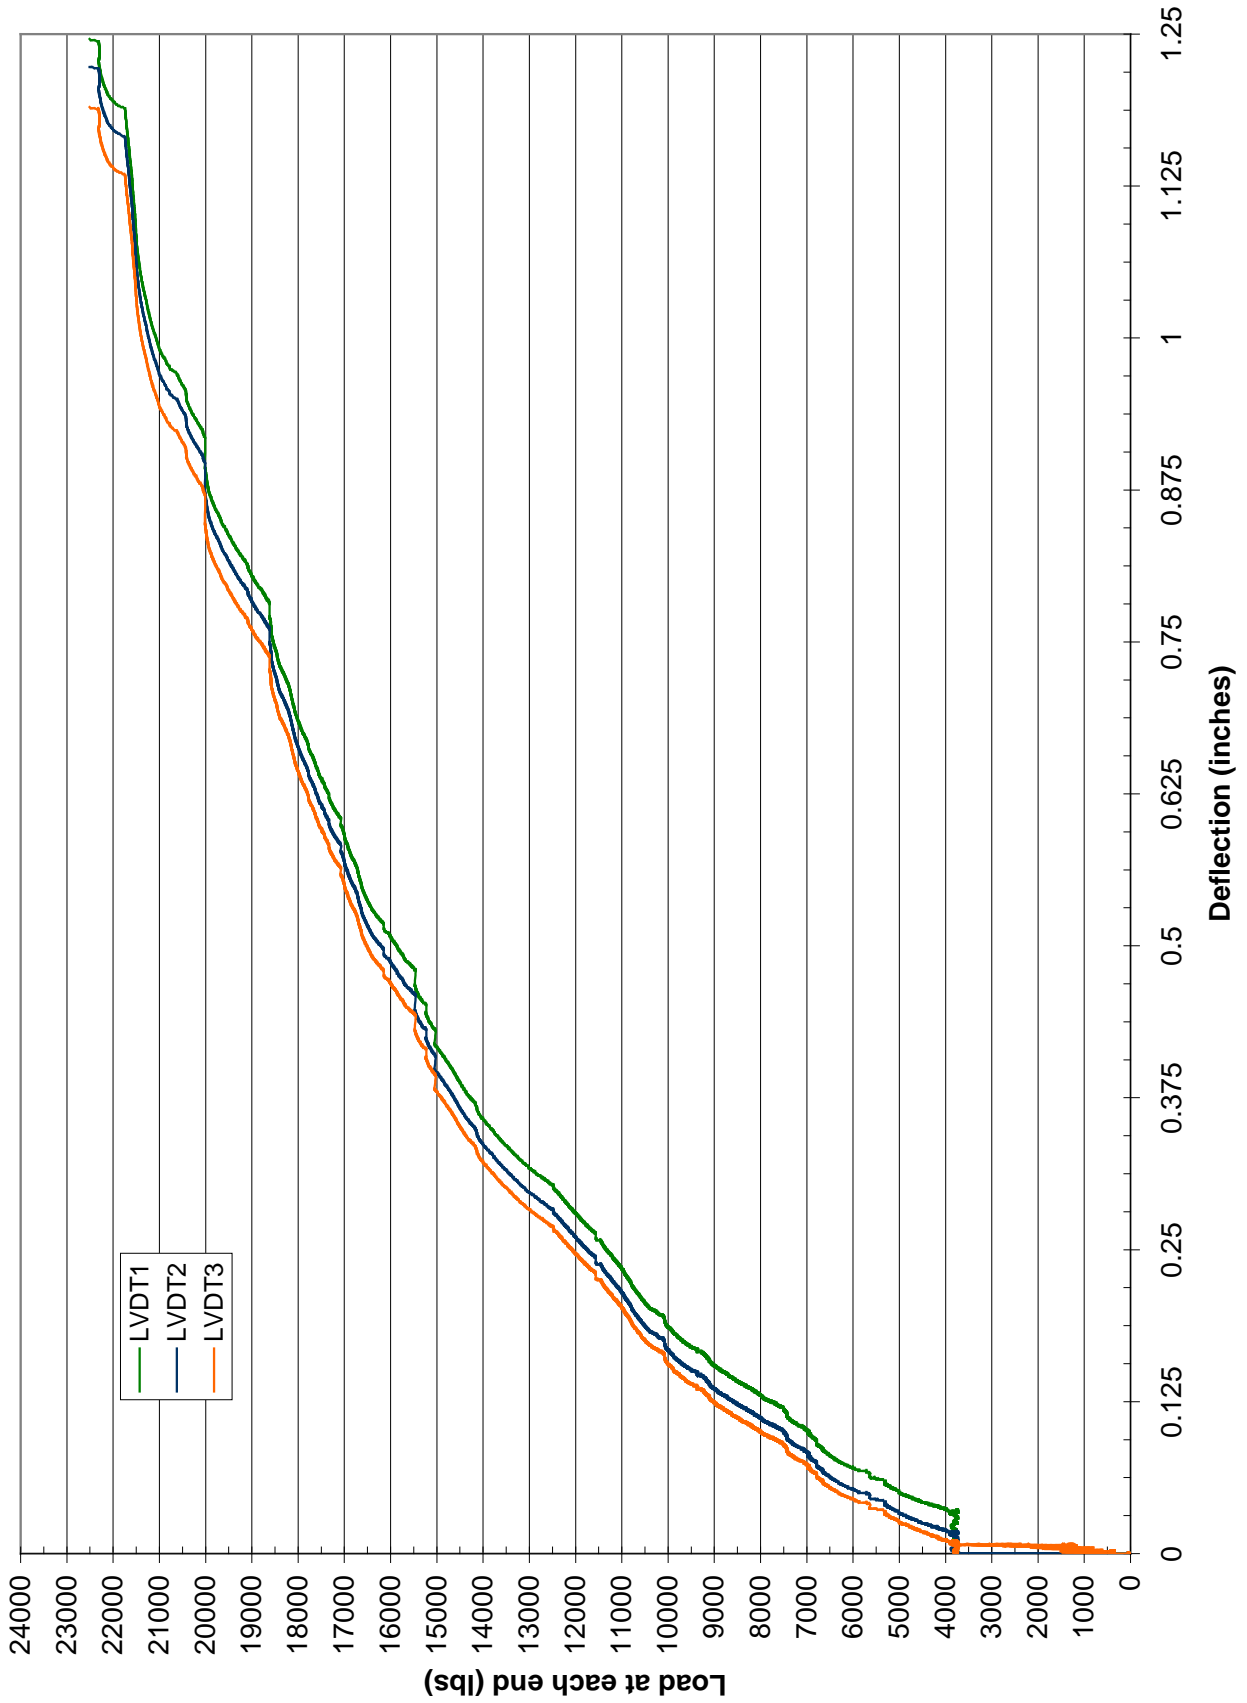
PVC Seawall Flexural Test (Specimen #3 - 800 Series)

Specimen #3 (800 Series) - 04/16/12 - 67°F			
Applied Load (lbs)	Displacement (LVDT)		
	1	2	3
1000	0.000"	0.001"	0.002"
2500	0.000"	0.001"	0.008"
5000	0.051"	0.034"	0.026"
7500	0.119"	0.100"	0.089"
10000	0.191"	0.173"	0.161"
15000	0.420"	0.399"	0.383"
20000	0.896"	0.876"	0.850"
22507*	1.255"	1.123"	1.197"
0 (1 min. recovery)	0.391"	0.366"	0.335"
