PERFORMANCE EVALUATION TEST REPORT

FORMTECH ENTERPRISES, INC.
126 Ben Burton Circle
Bogart, Georgia 30622

Report No.: C9598.02-106-31
Test Dates: 07/08/14
Through: 10/20/14
Report Date: 11/10/14
Test Record Retention Date: 10/20/18
Revision 1: 04/15/15

Product: Truline Hybrid Sheet Piling System

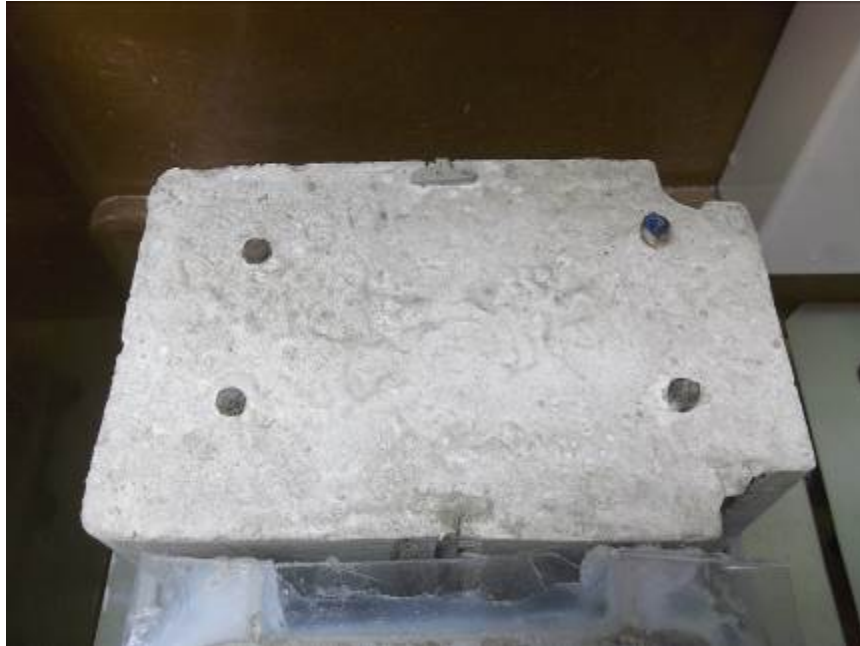
Photo No. 1
Full-Exposure Specimen in Salt Fog Exposure Chamber

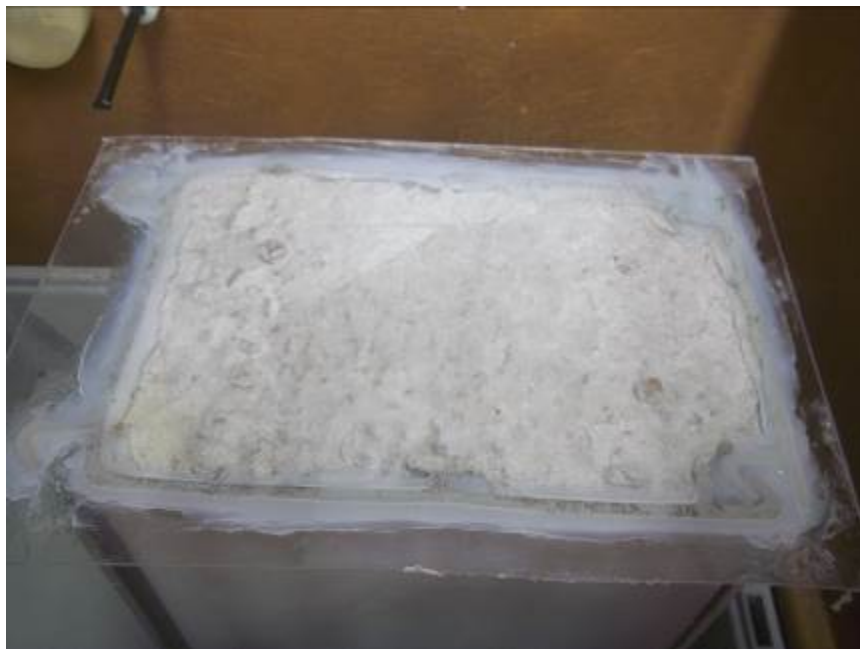
Photo No. 2
Sheathed Specimen in Salt Fog Exposure Chamber

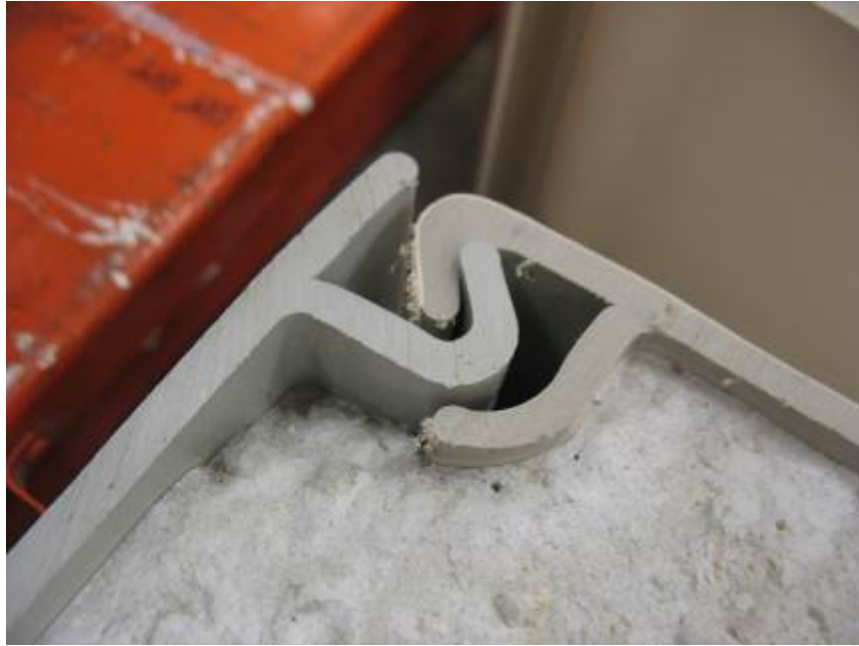
Photo No. 3
Truline System Sheathed Specimen Section Joint Detail - Unsealed

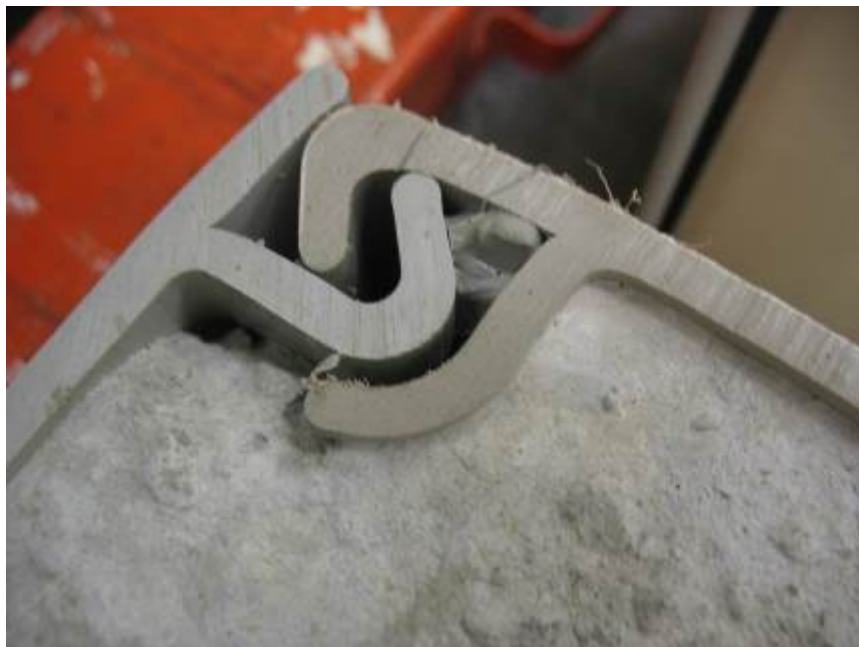
Photo No. 4
Truline System Sheathed Specimen Section Joint Detail - Sealed

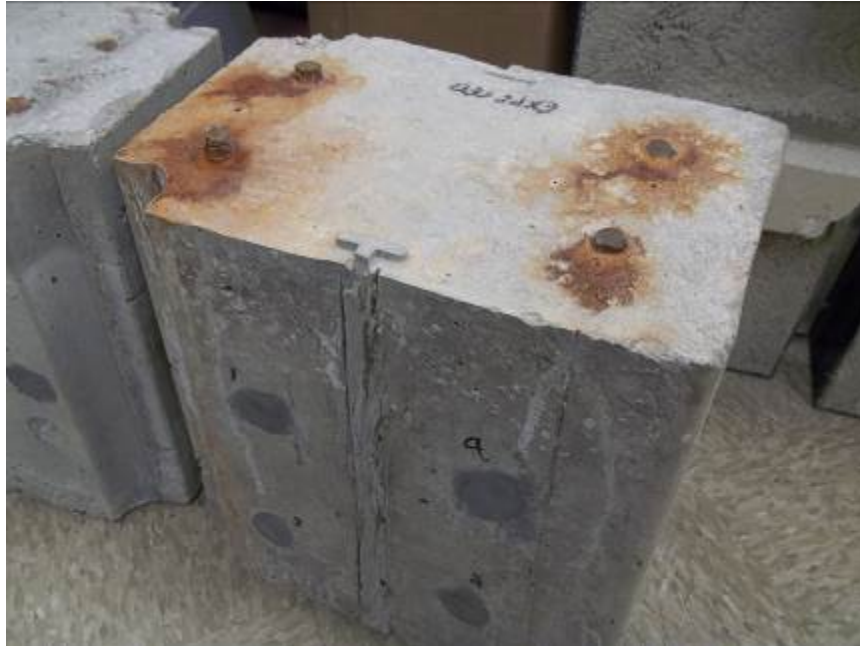
Photo No. 5
Full Exposure Comparative Specimen - Post Test Condition

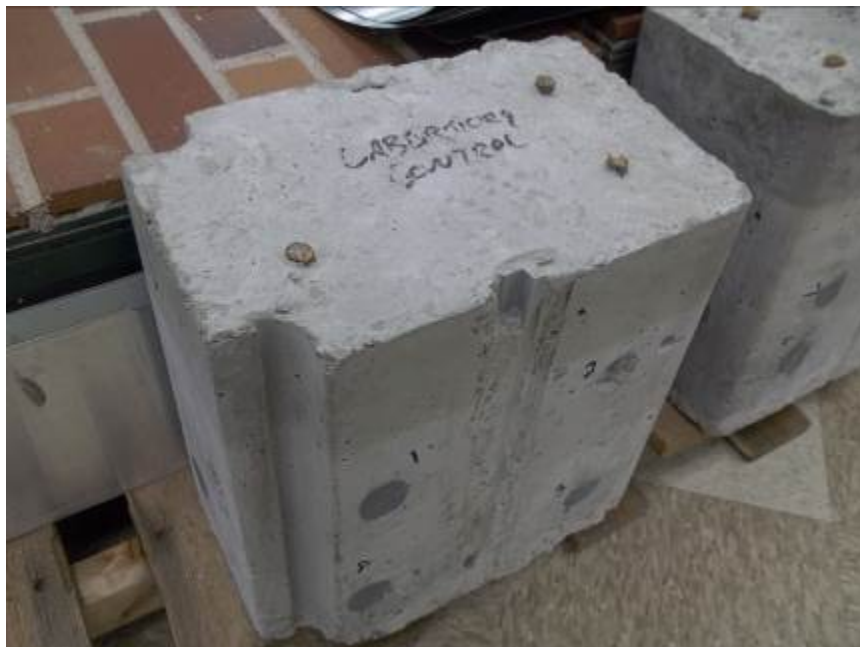
Photo No. 6
Laboratory Conditioned (Unexposed) Control Specimen

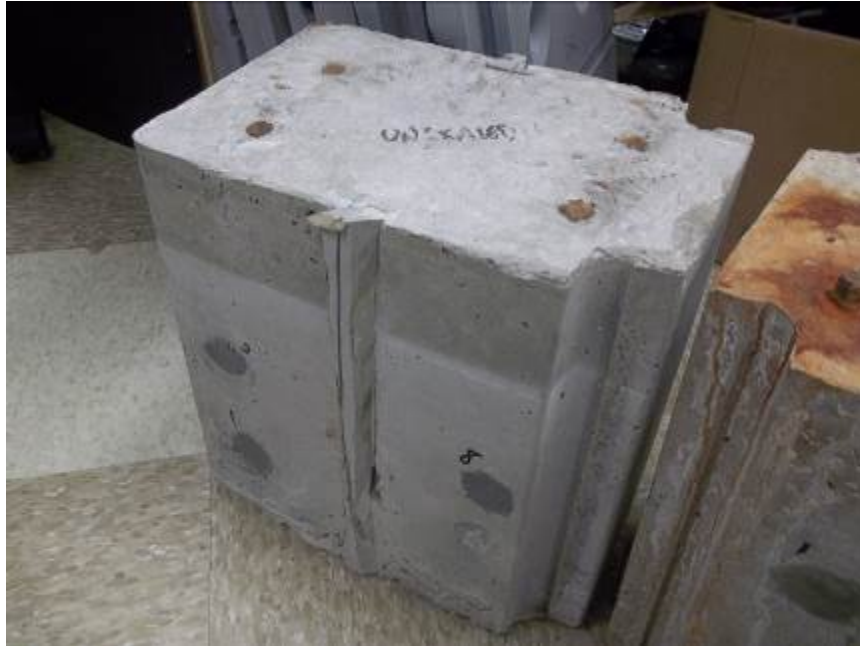
Photo No. 7
Truline System Sheathed Specimen (Unsealed Joint) - Post Test Condition

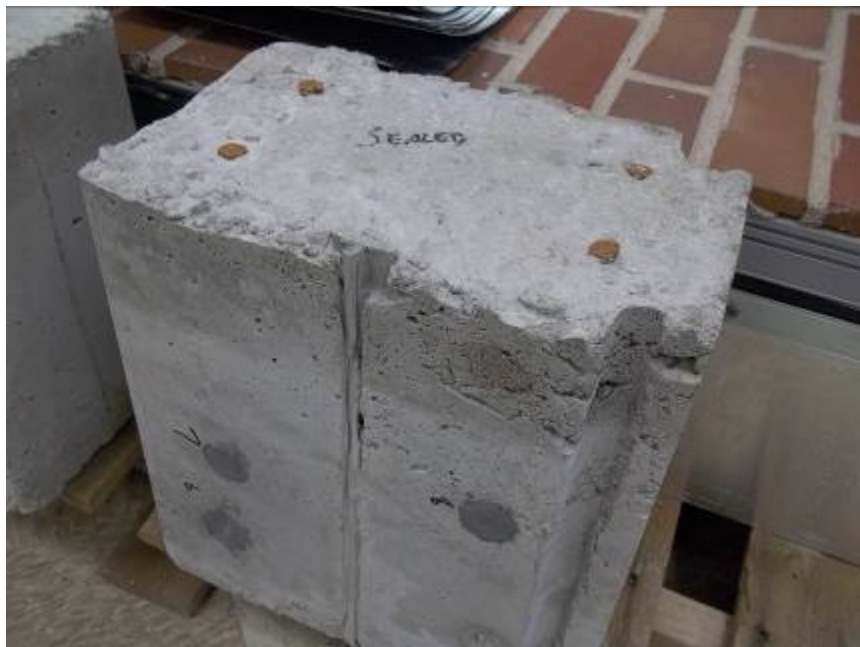
Photo No. 8
Truline System Sheathed Specimen (Sealed Joint) - Post Test Condition
